Motor Vehicle Forensic Analysis Report

People of the State of New York v.
Nauman Hussain

REFERENCED INVOLVED SUBJECT VEHICLE: 2001 Ford Excursion Stretch Limousine,
VIN 1FMNU40S51EB10299

DATE OF CRASH: October 6, 2018 @ 1355 Hours

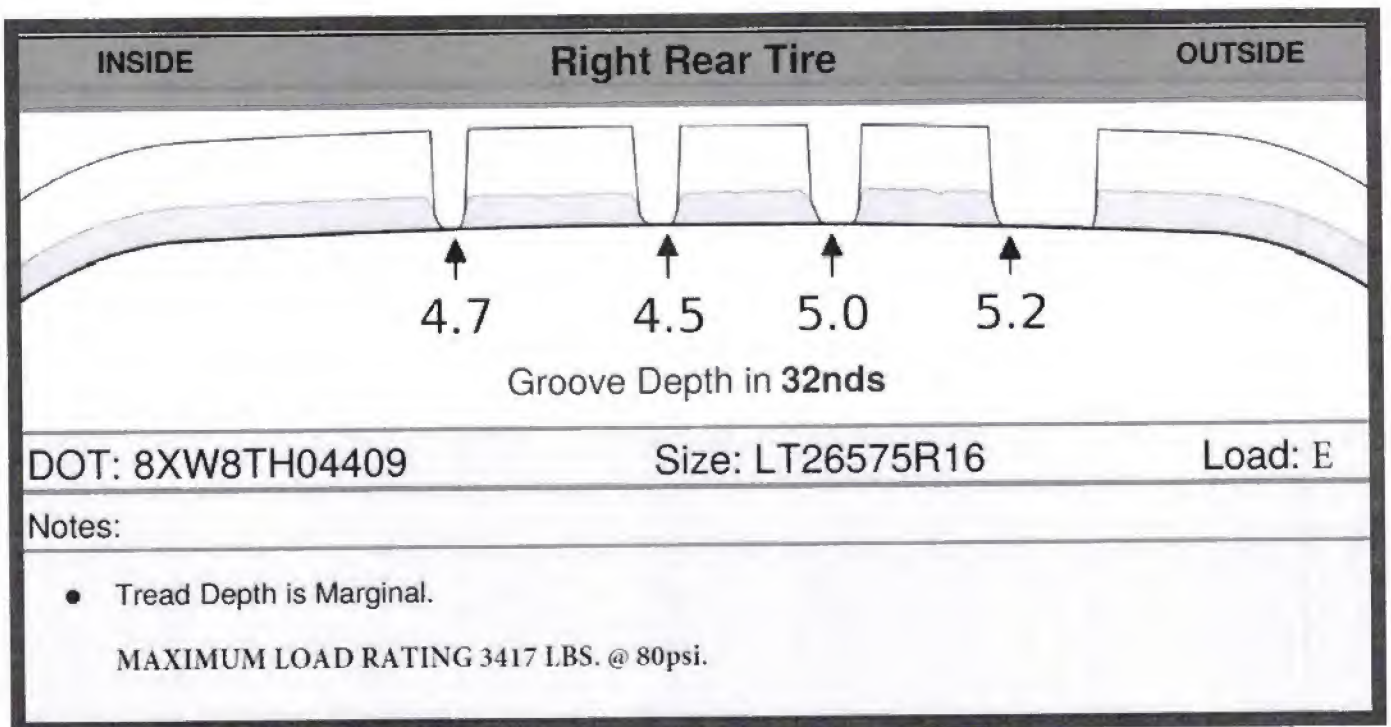
The inspection of the four tires and wheels of the 2001 Ford Excursion stretch limousine in this case revealed no evidence of pre-crash failure conditions. Tire tread depth, performed with specialized laser equipment, was sufficient at all locations. However, the wheel installed at the left front of the vehicle was that of steel design, as opposed to the original manufacture alloy composition wheels located at the remaining three locations on the vehicle. Additionally, the tire installed at the left front of the vehicle was that of a size of LT245/75R16, while the tire size at the remaining three locations was that of LT265/75R16 -- the original manufacturer tire size.

The results of the specialized tire scan laser equipment, along with tire notations, are provided on the next two pages of this expert report.

Summary of Analysis, Tires/Wheels of the Vehicle: *The examination and analyses of the tire/wheel components of the 2001 Ford Excursion stretch limousine in this case revealed that although tire failure was not a causal aspect of this multiple fatality crash, the following deficiencies existed during the pre-crash operation of the vehicle:*
